Report of Geotechnical Investigation  
Dam Safety Assessment of Coal Combustion  
Surface Impoundments  
Kentucky Utilities, a Subsidiary of E.ON U.S.  
Tyrone Generating Station, Tyrone, KY

AMEC Project No. 3-2106-0177.0004

September 2010

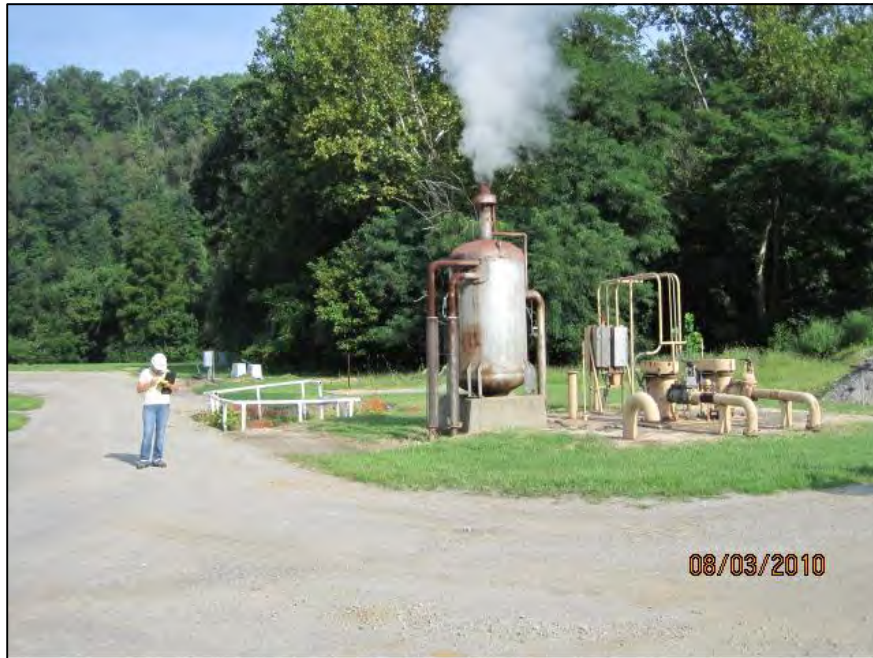
1-1

OIL AND WATER SEPARATOR, STEAM RELEASE, LOCATED 200 FEET SOUTHWEST OF ASH POND

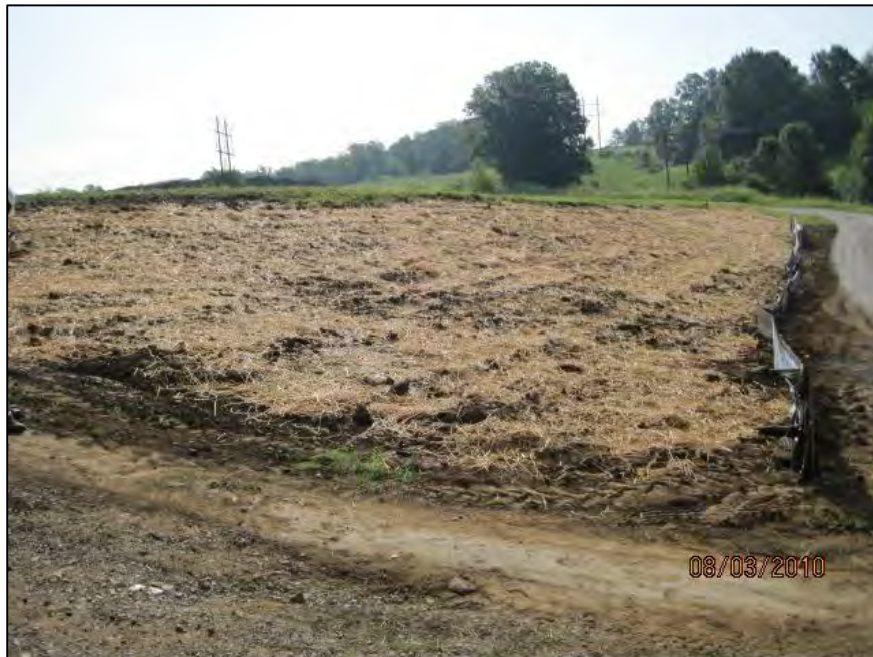
1-2

RESEEDED AREA ALONG SOUTH DOWNSTREAM DIKE SLOPE

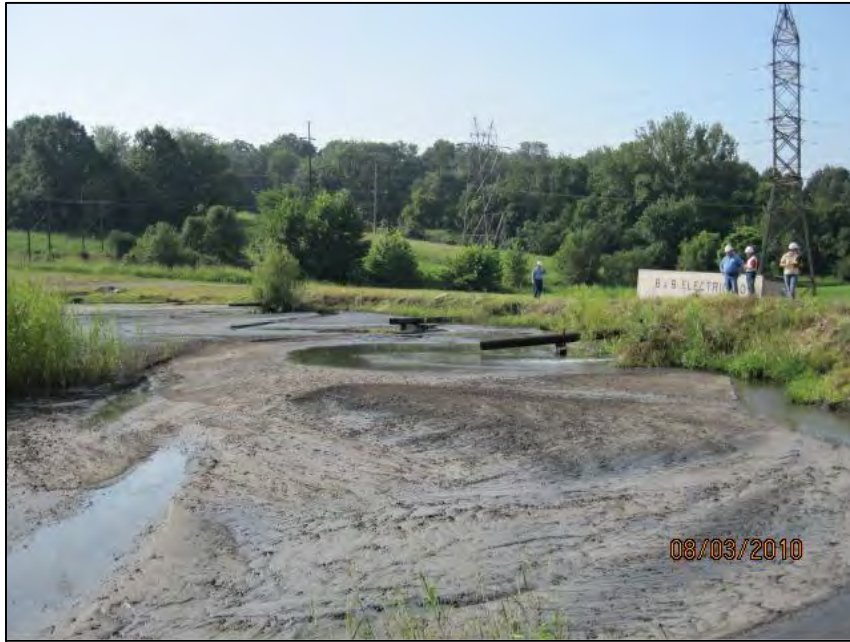
**1-3**

**INLET PIPES FROM UNIT 3, COAL PILE RUNOFF POND AND LIFT STATION**

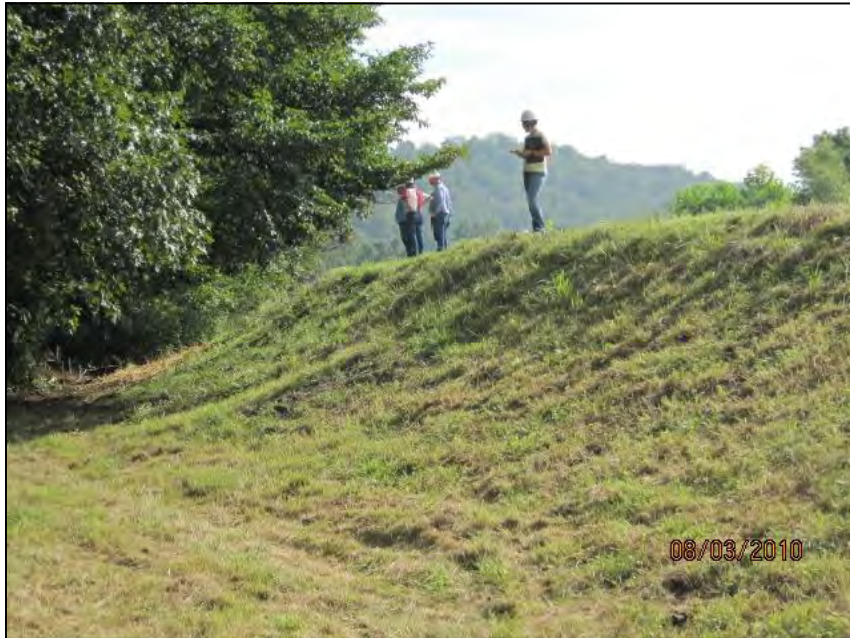
**1-4**

**STEEP EMBANKMENTS ALONG SOUTHWESTERN DIKE**

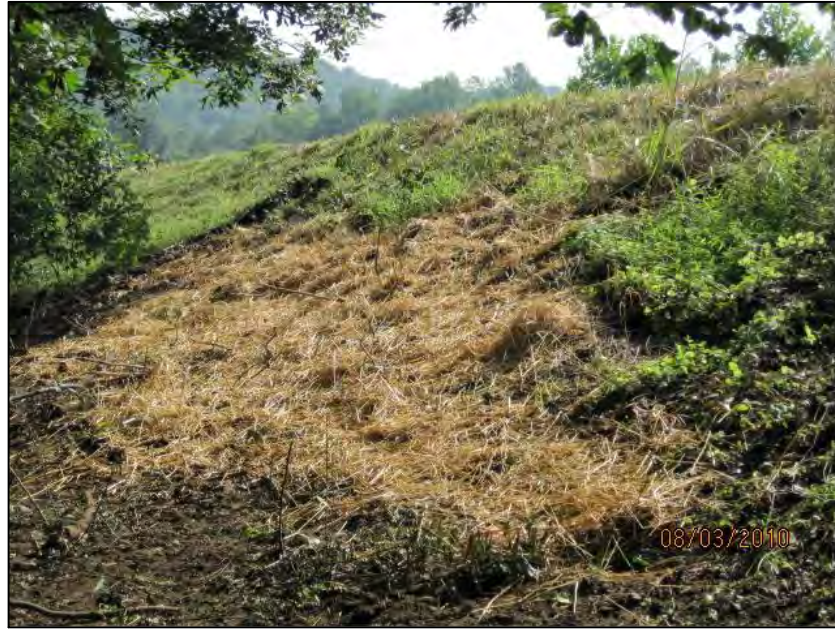
**1-5**

**RESEEDED AREA ALONG WESTERN DIKE**

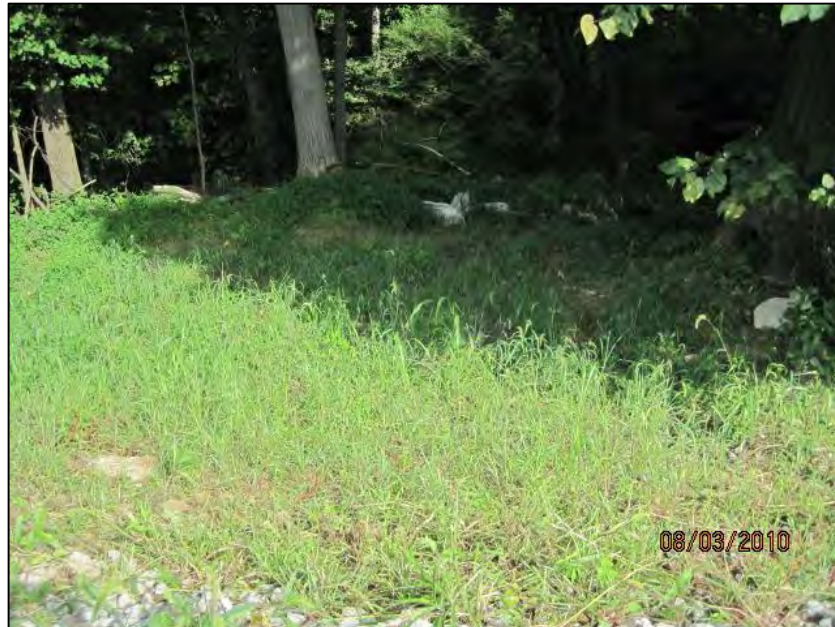
**1-6**

**AREA OF 2009 EARTH SLOPE REPAIR BETWEEN THE PLANT COOLING WATER CANAL  
AND THE TOE OF THE WESTERN DIKE OF THE ASH POND**

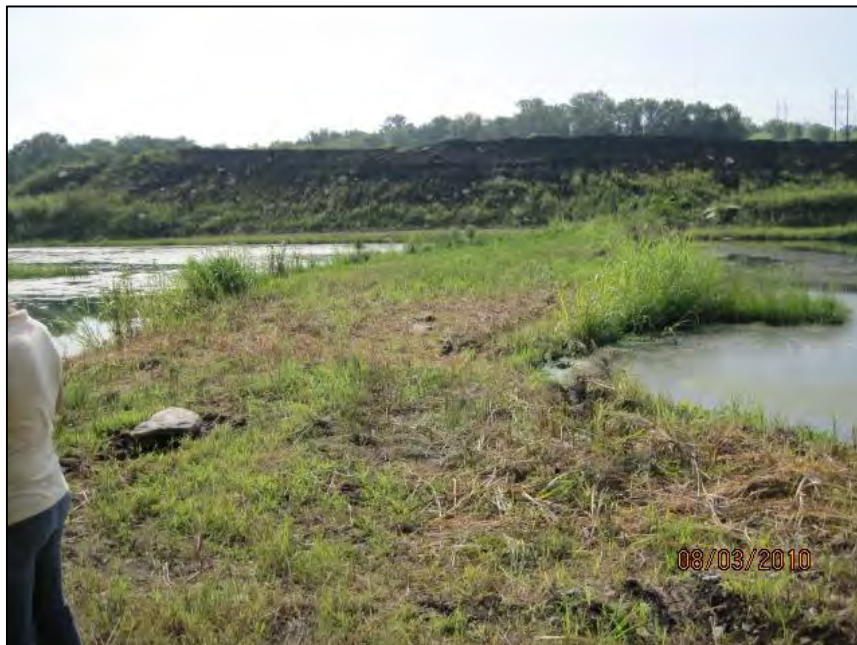
**1-8**

**STANDING IN LOW AREA OF WEST DIKE LOOKING EAST AT WORKING PLATFORM DIVIDING DIKE**

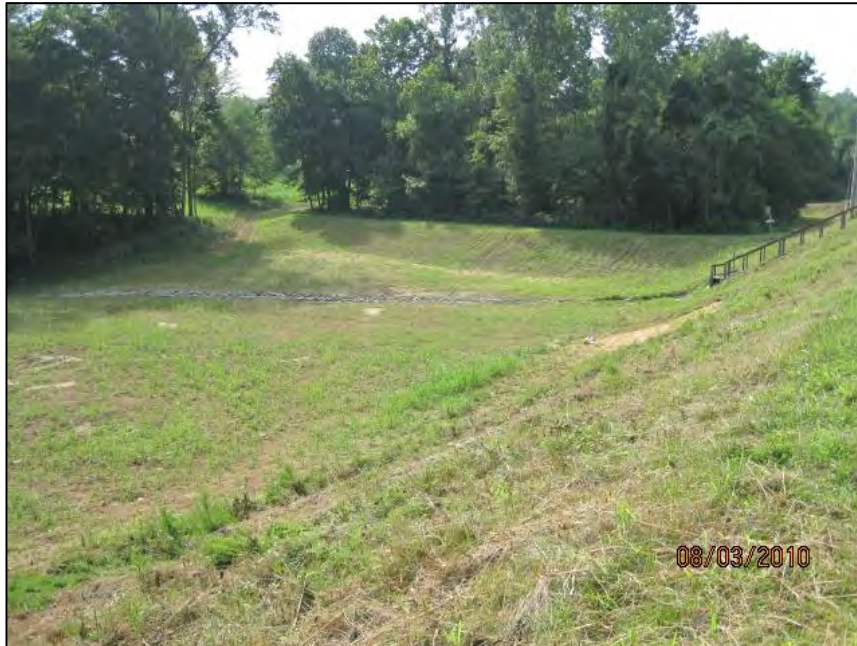
1-9

LOOKING NORTHEAST AT LOCATION OF FORMER SECONDARY POND, RIGHT IS  
DOWNSTREAM SLOPE (UNEVEN) OF NORTH DIKE, CUT AT TOE OF SLOPE

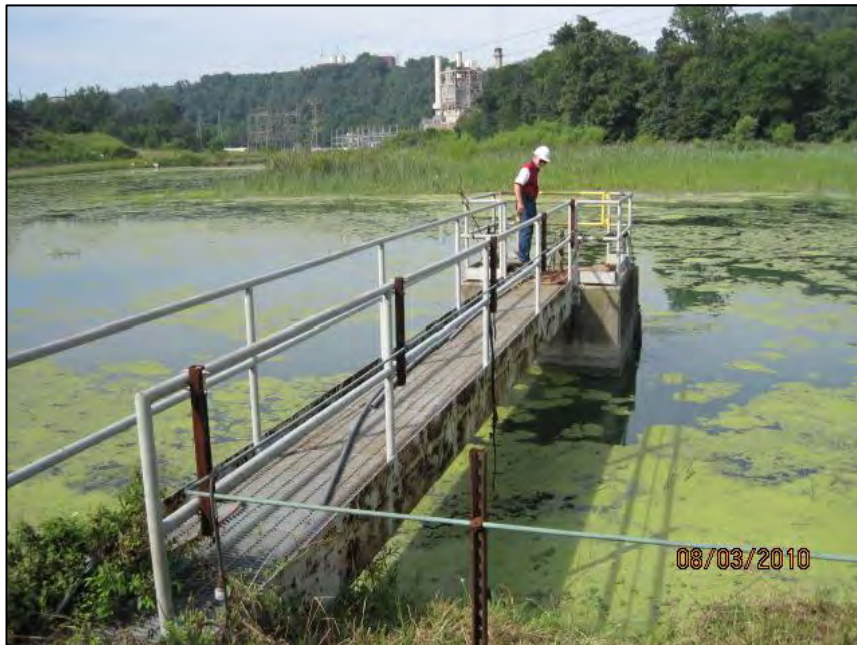
1-10

PRIMARY OUTLET STRUCTURE

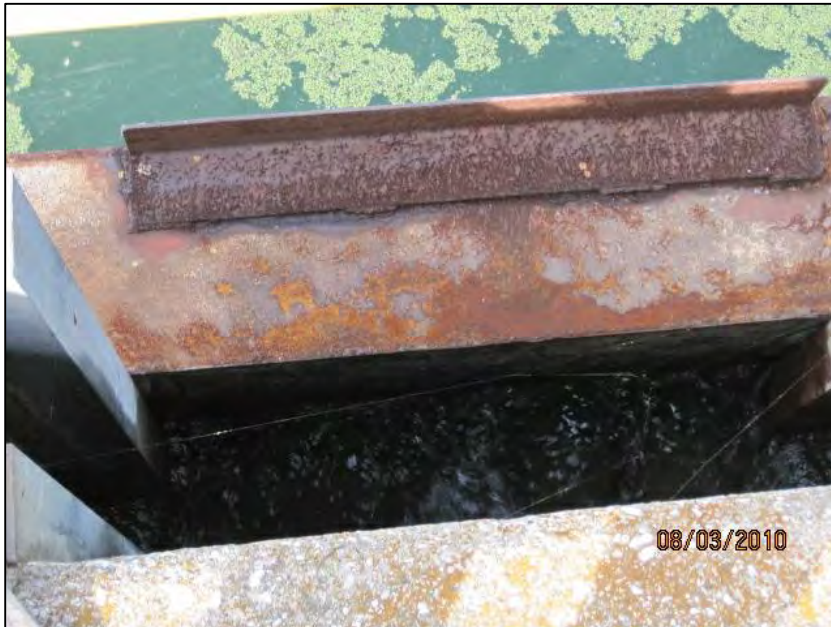
**1-11**  
**SKIMMER ON OUTLET STRUCTURE**

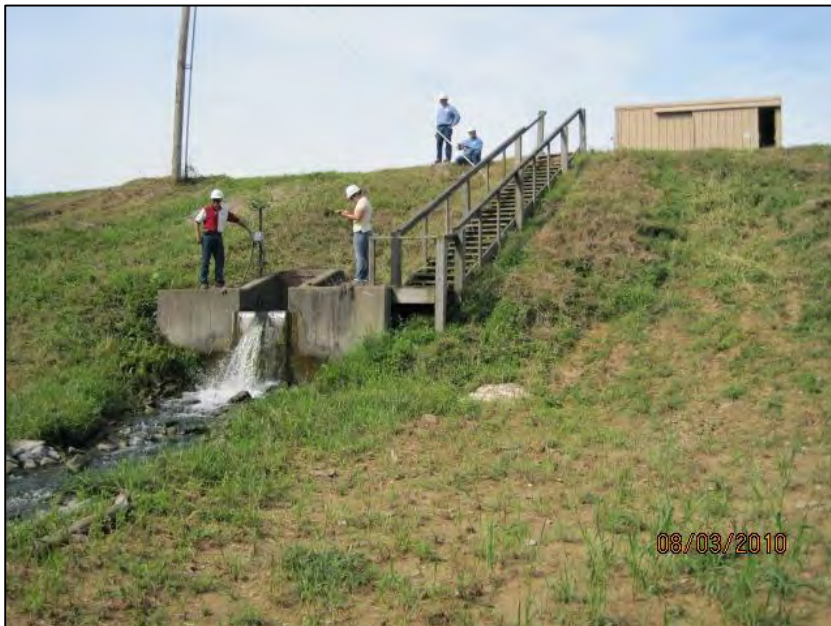
**1-12**  
**PRIMARY OUTLET/MONITORING POINT OF ASH POND AT TOE OF NORTHERN DIKE, NOTE STEEP/ERODED AREA TO RIGHT**

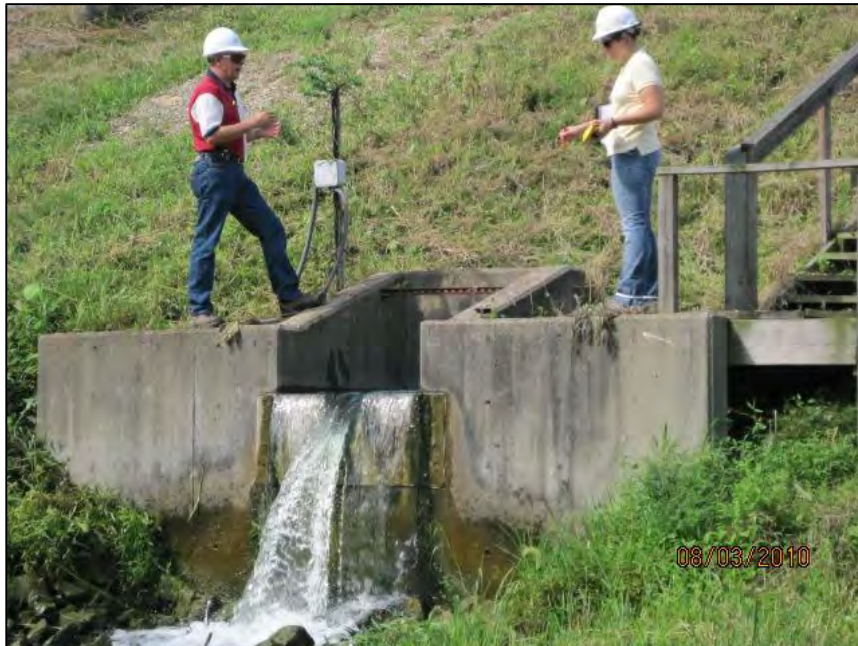
1-13

PRIMARY OUTLET/MONITORING POINT OF ASH POND ALONG NORTHERN DIKE

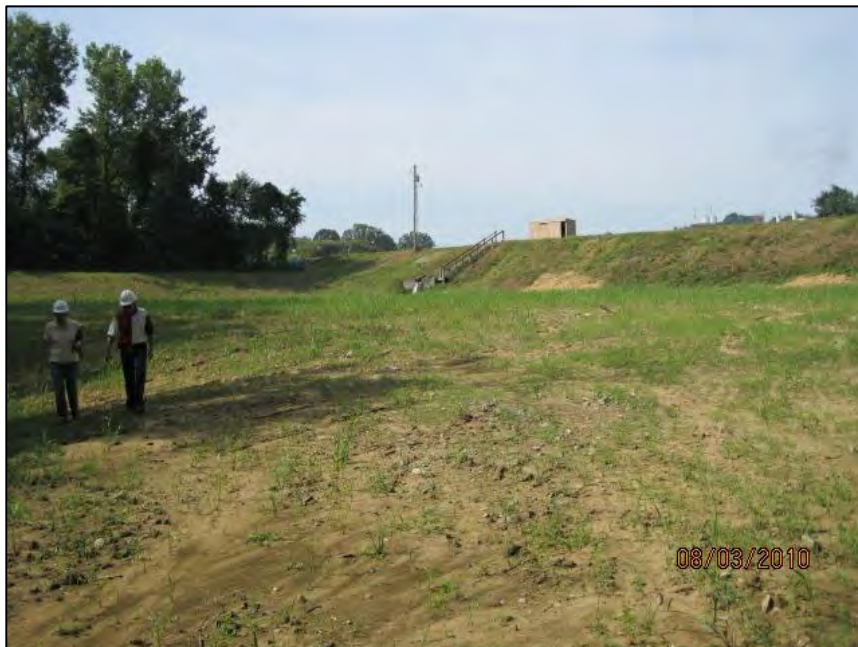
1-14

LOOKING SOUTH FROM LOCATION OF FORMER SECONDARY POND,  
DOWNSTREAM SLOPE OF NORTH DIKE IN BACKGROUND

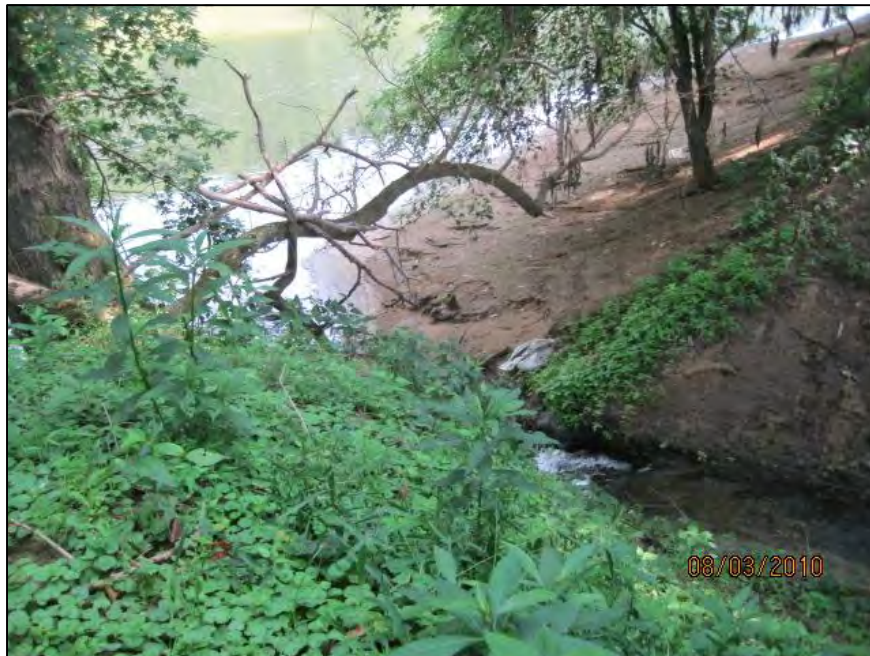
**1-15**  
**DISCHARGE POINT TO KENTUCKY RIVER**

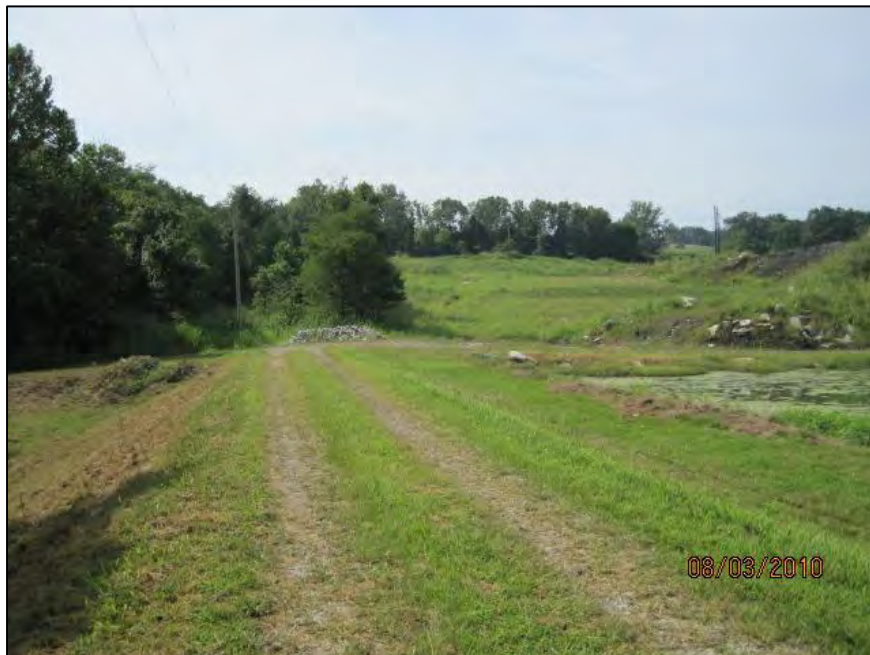
**1-16**  
**VIEW FROM NORTHERN DIKE LOOKING EAST, BACKGROUND AREA IS NORTH OF ASH STACK**

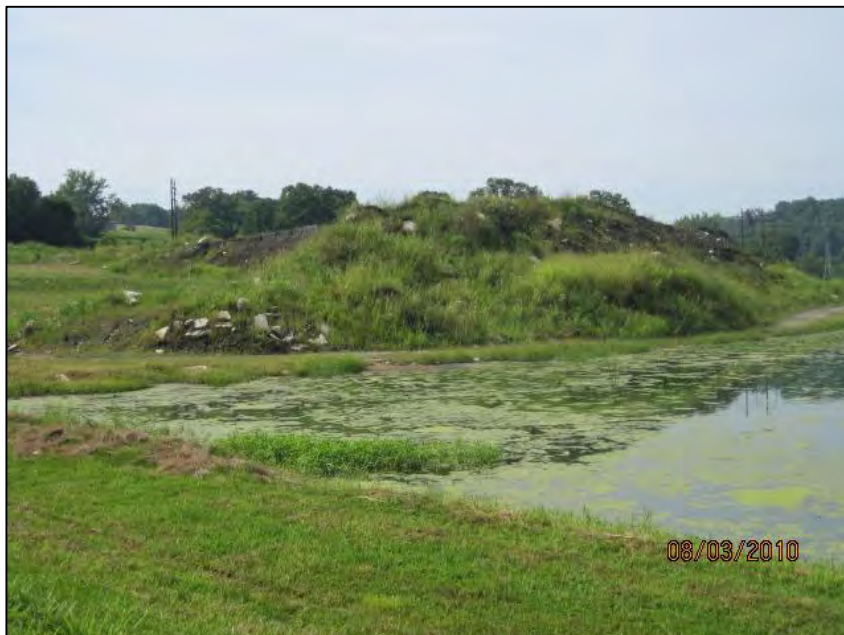
**1-17**

**VIEW FROM NORTHERN DIKE LOOKING SOUTHEAST TOWARDS ASH STACK**

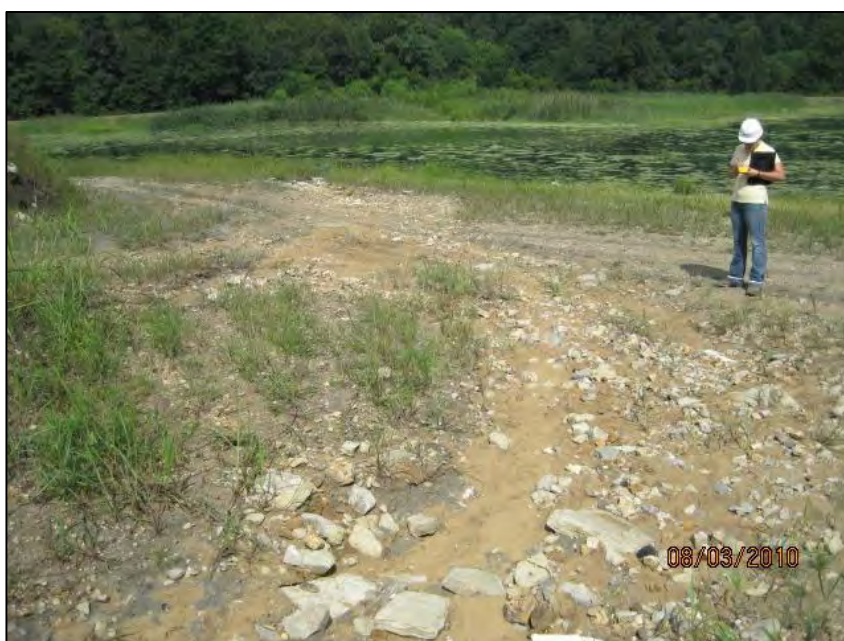
**1-18**

**VIEW ALONG WESTERN DIKE AT TOE OF ASH STACK NOTE DRAINAGE DITCH ALONG BASE OF STACK**

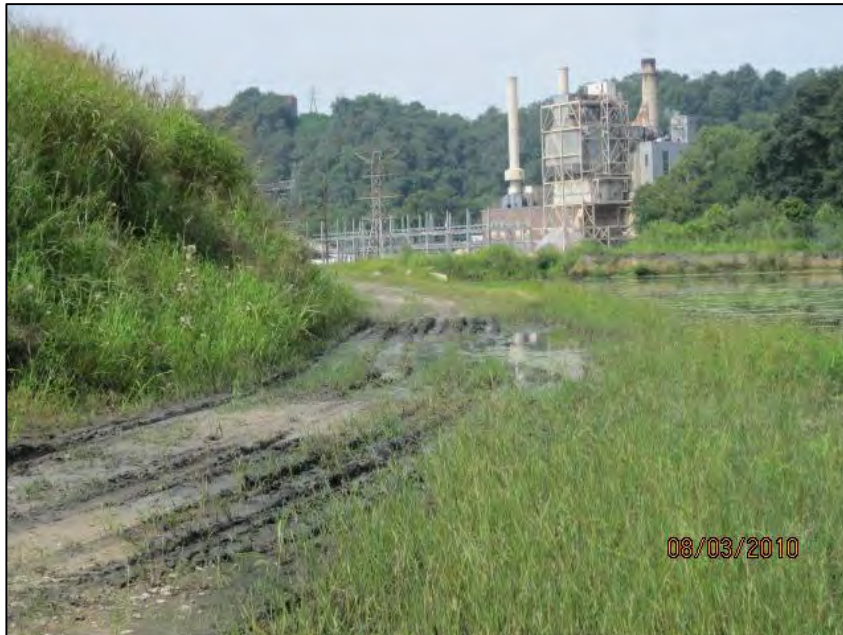
**1-19**

**VIEW ALONG WESTERN DIKE LOOKING SOUTH TOWARDS POWER PLANT**

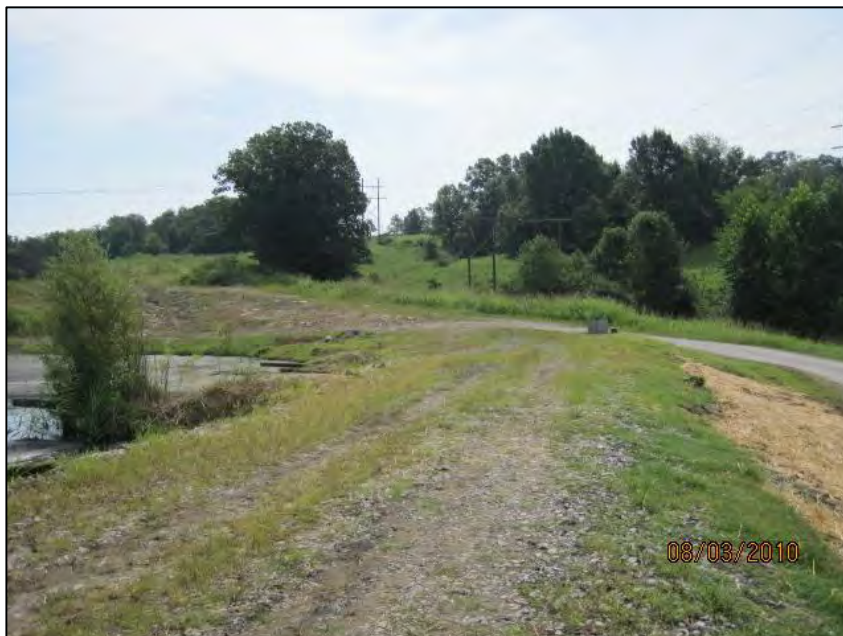
**1-20**

**VIEW FROM SOUTHERN DIKE LOOKING EAST ACROSS CREST TO TIE-IN TO ORIGINAL GROUND,  
BACKGROUND IS AREA SOUTH OF ASH STACK**

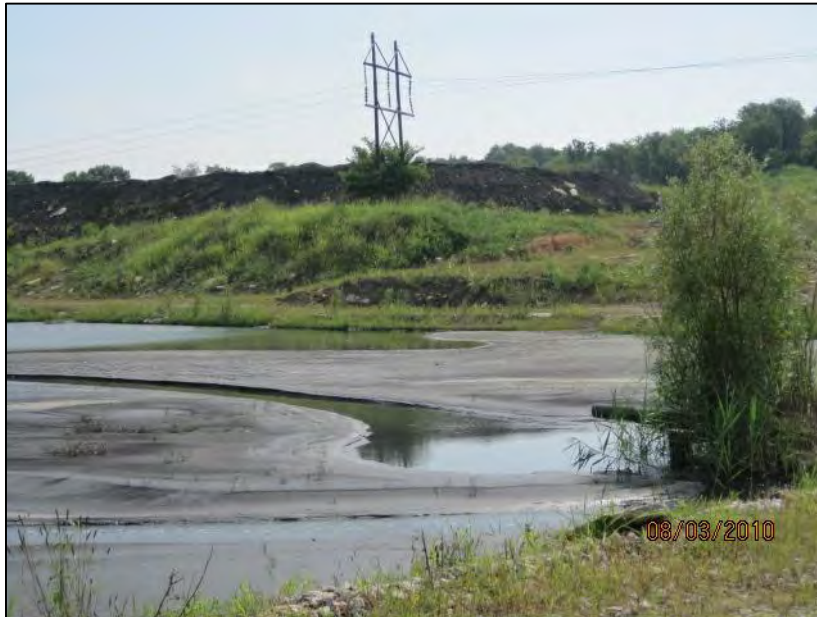
**1-21**

**VIEW FROM SOUTHERN DIKE LOOKING NORTHEAST TOWARDS ASH STACK**
